December 19, 2014

Re: SR 99: Shaft Excavation Status Report & Action Items for Discussion
TBM Access Shaft, Seattle, WA

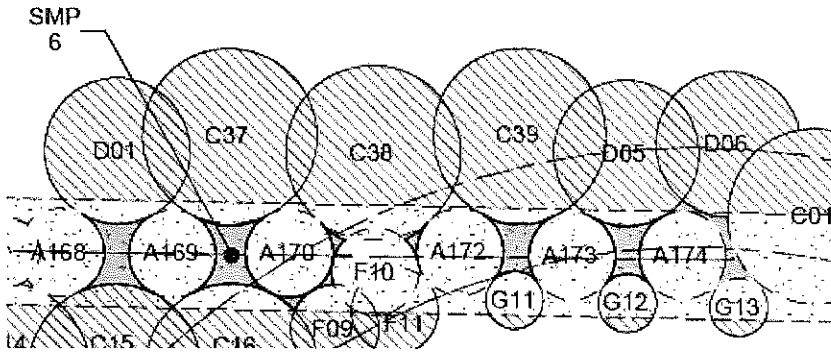
Reviewing the as-built locations of the shaft piles at regular vertical intervals, we are concerned that there is a potential for much larger untreated soil zones to exist that were not considered in the design, depending on the location of the SESMP piles. The design pile layouts shown in Figure 1 and Figure 2 indicate the originally expected in-fill or void areas in solid gray.

Figure 1: West Shaft Wall Design In-Fill Areas (Solid Gray Shaded Areas)

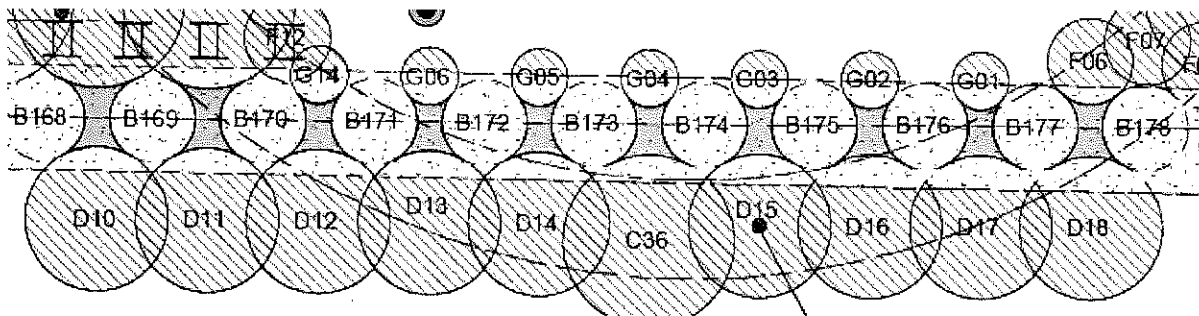
Figure 2: East Shaft Wall Design In-Fill Areas (Solid Gray Shaded Areas)

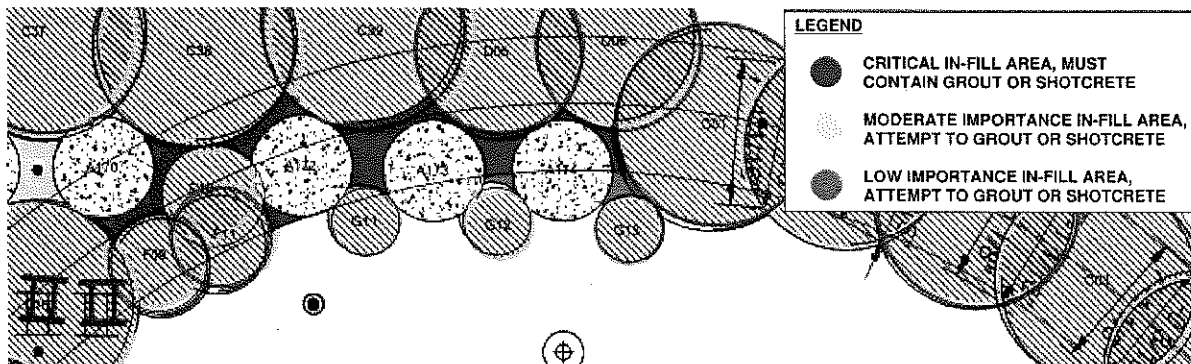
Upon review of the as-built secant pile locations with respect to the SESMP piles, there appears to be a potential for much larger in-fill areas than initially intended in the design. Given the observed untreated soil zones in the in-fill areas to date, the as-built pile layouts shown in Figure 3 and Figure 4 indicate the extent of potential untreated zones in the colored areas. Potentially untreated soil zones that fall within the theoretical design compression ring and may have a significant effect on the stability of the shaft structure are shaded red. A continuous compression ring of adequate thickness and strength is essential for the structural stability of the wall.

Figure 3: West Shaft Wall Pile As-built (Potential Void Areas Highlighted in Yellow or Hatched)

While it is likely the in-fill areas are larger than initially intended, we do not believe they are as extensive as shown in the as-built pile layouts of Figure 3 and Figure 4. For example, Figure 4 shows the potential for a nearly continuous void through the entire width of the shaft wall between piles B177/F06 and B178/D18. However, if this were the case, we believe that significant seepage and ground loss would have been observed during the course of excavation to date. Given the rate of seepage observed and the lack of ground loss outside the shaft, it is likely there is some continuous wall present between piles B177/F06 and B178/D18.

The source of the uncertainty for the as-built condition is the lack of as-built data for the SESMP piles. Once the as-built of the SESMP piles is incorporated into the existing overall shaft as-built drawings, a more refined analysis of the ring-structure can be completed and critical in-fill repair locations identified.

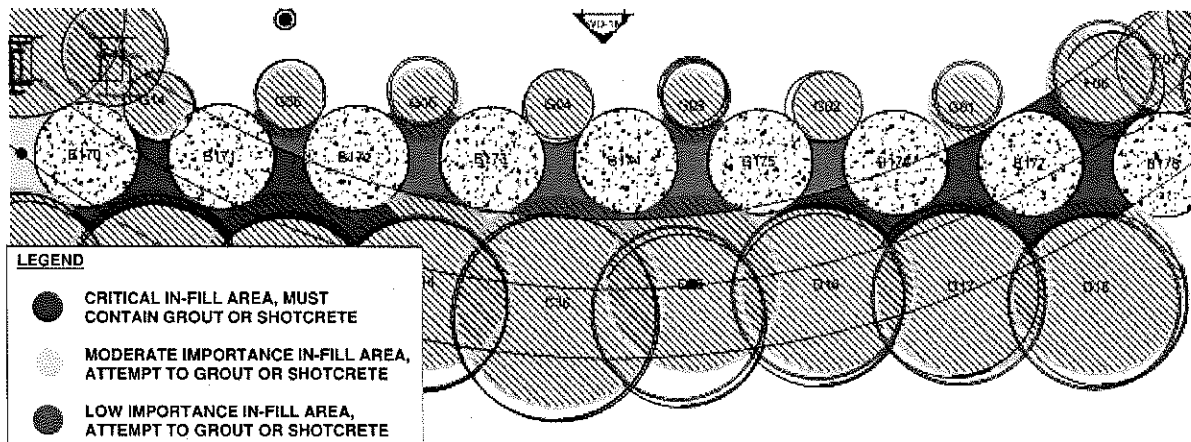
Figure 4: East Shaft Wall Pile As-built (Potential Void Areas Highlighted in Yellow or Hatched)
