King County

Roxhill Wetland Hydrology Study

Initial Findings

February 11, 2020

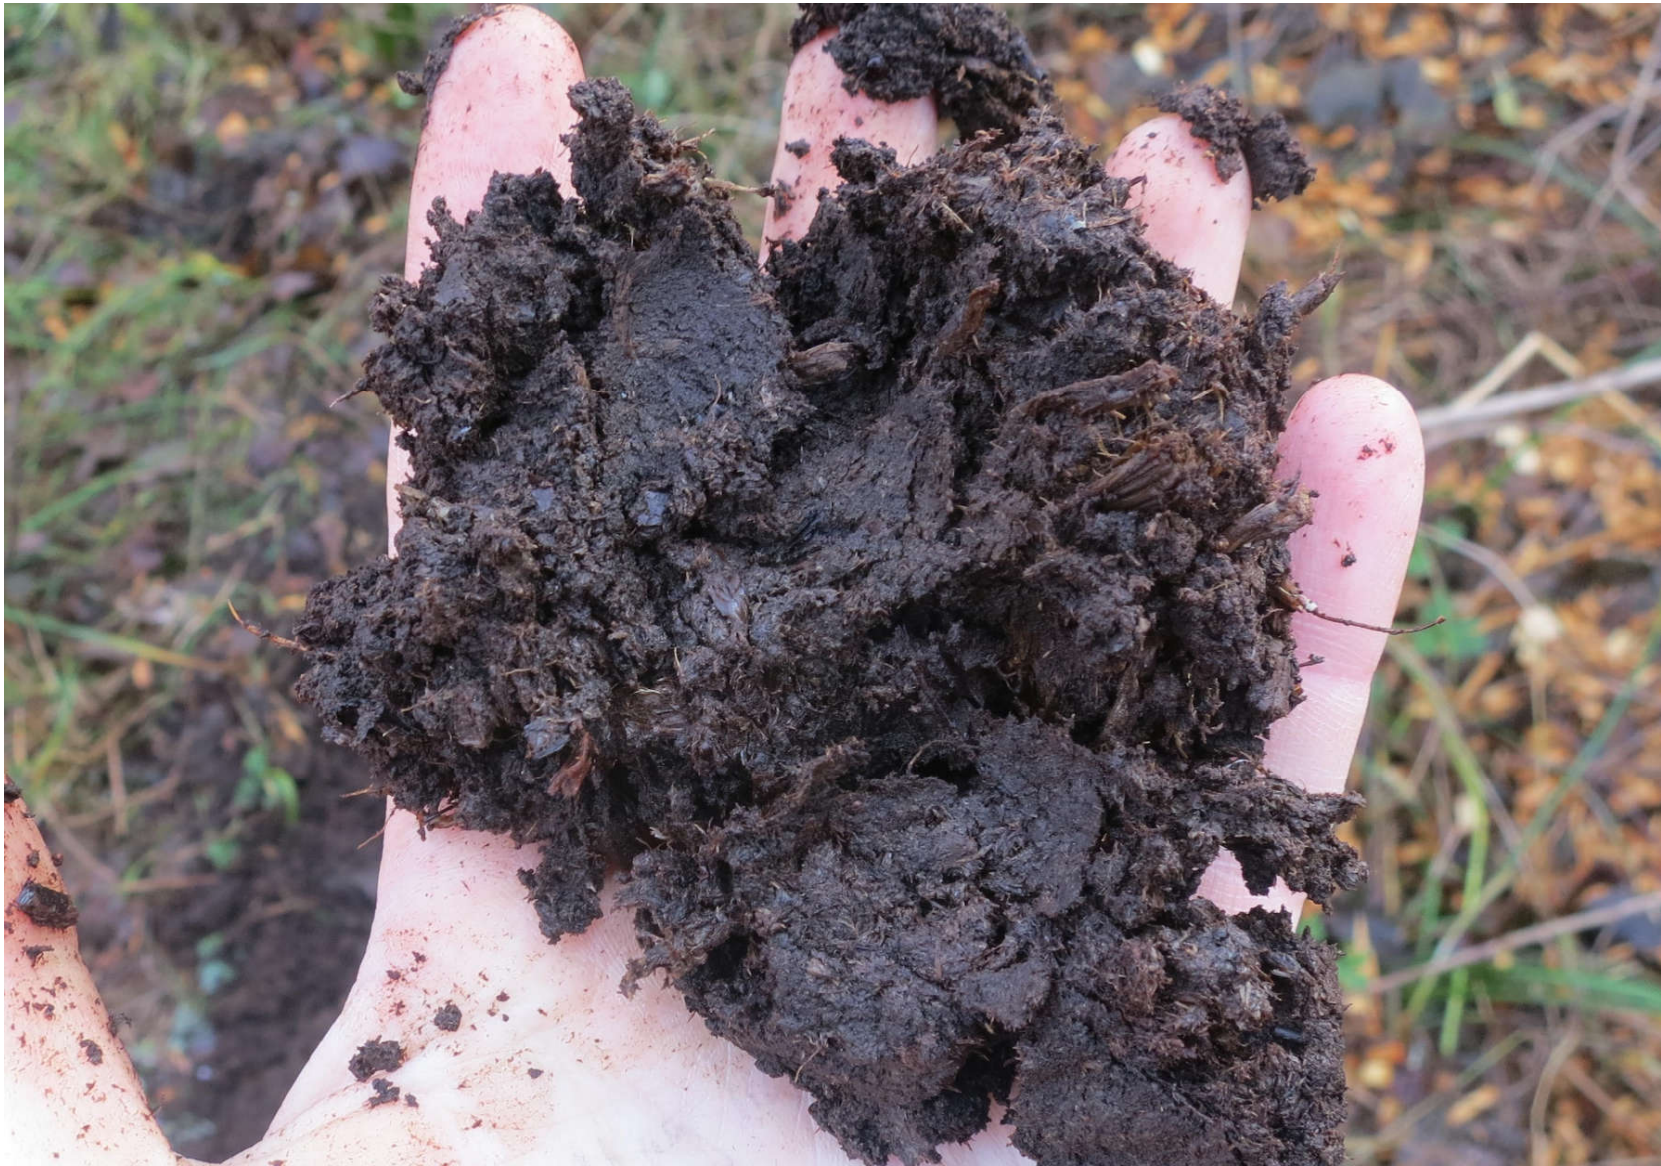
USGS Geologic Mapping

Nonglacial Deposits (Holocene)

Qw - Wetland deposits
-

Qp - Peat
-

Qvr - Vashon recessional outwash deposits
-

Qvt - Vashon subglacial till
-

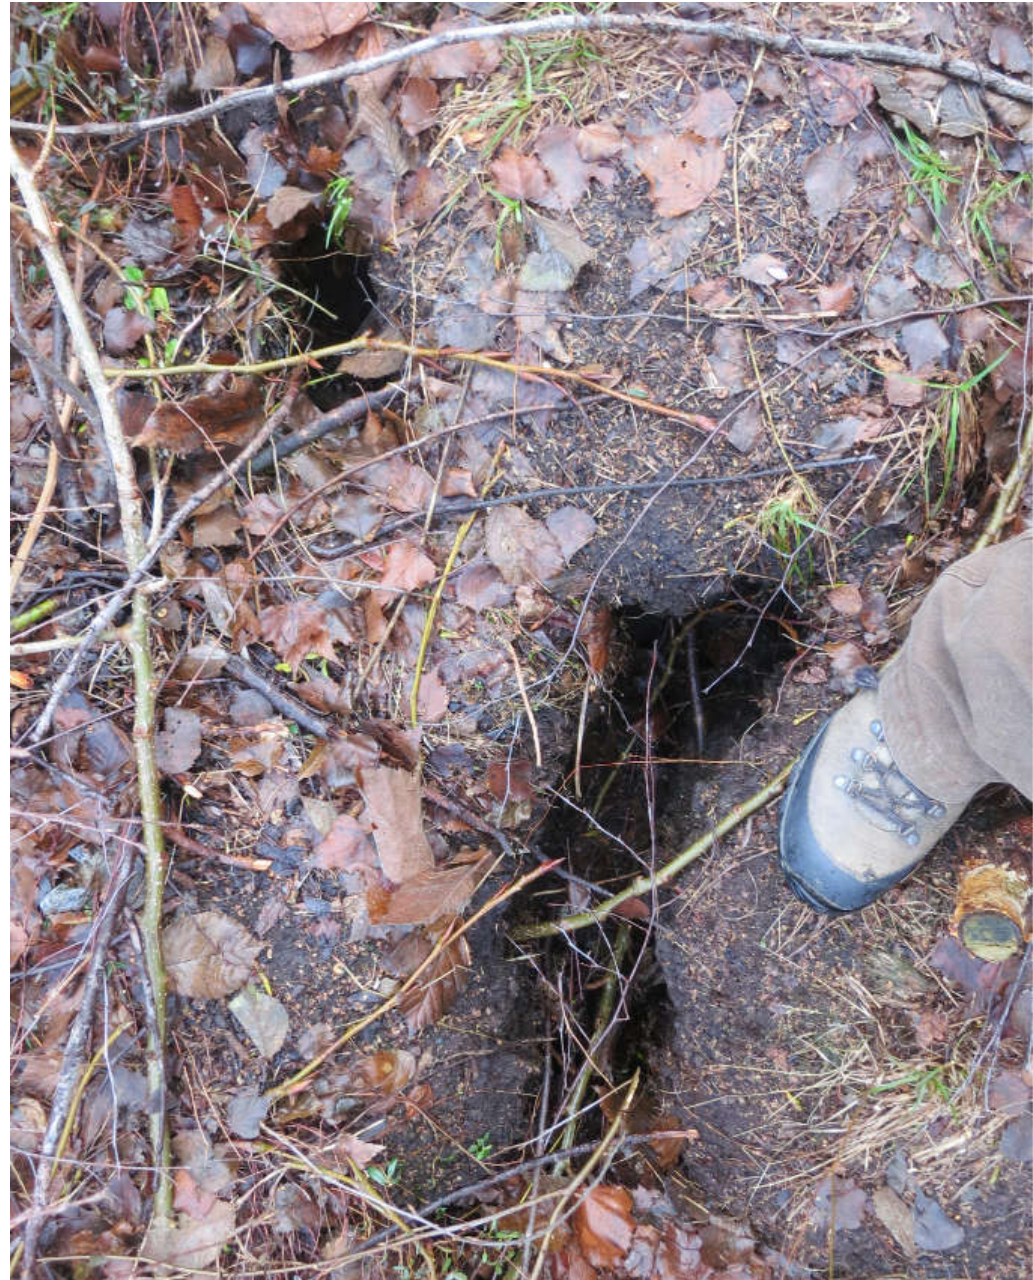
2019 Soil Investigations

- We encountered voids (macropores) in 6 out of the 12 soil investigations
- Development of voids is consistent with the literature for drained peat wetlands

- ▶ Excavation to install utilities and SW Barton street
- ▶ Peat deposit degradation results in voids that allow for accelerated lateral water loss
