WALKING ON LOGS: LANDSCAPE RESTORATION PROJECT

ANDSCAPE DEVELOPMENT
WALKING ON LOGS
SEATTLE, WA

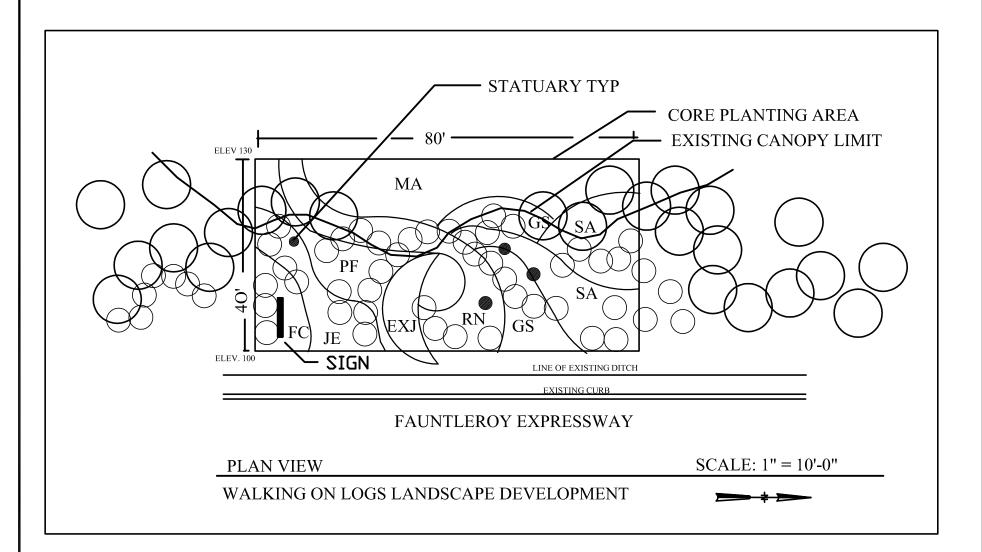
The design as presented provides a back drop of Quaking Aspen spaced as shown with Swedish Aspen mixed among the sculpture figures as shown. A limited list of shrubs and groundcovers will be planted in drifts (spacing as indicated). No clearing or grading will be done on the site. Plant materials will be placed in hand-dug pits using a compost material and native soils as back fill. The trees will be staked until establishment.

The Aspen to be planted at maturity will likely be 40 feet tall due to the soil conditions. The existing deciduous and evergreen trees located at the top of the slope along the east side Fauntleroy Way SW are 40 to 50 feet tall. With the Aspen planted down slope from these trees, there is little likelihood that views will ever be blocked.
